Physical, Chemical, and Mechanical Bonding Concept/Mechanisms for Joining Steel and Composite Sections

Final Report

Vijay Gupta

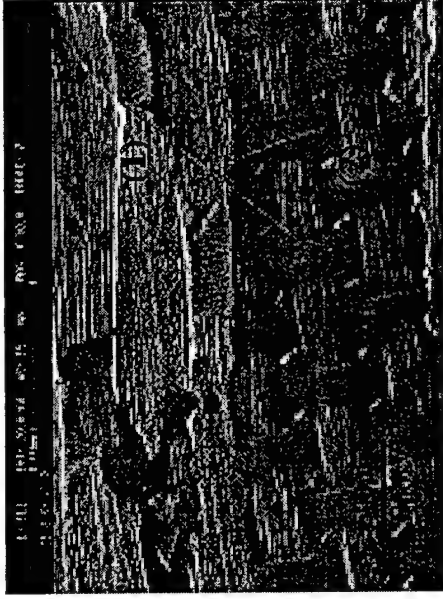
Fig. 22

Steel/Epoxy/E-glass (after 1 day seawater immersion)

a. SEM: fracture surface of steel beam with some epoxy attached

b. EDX analysis on the part shown in figure a

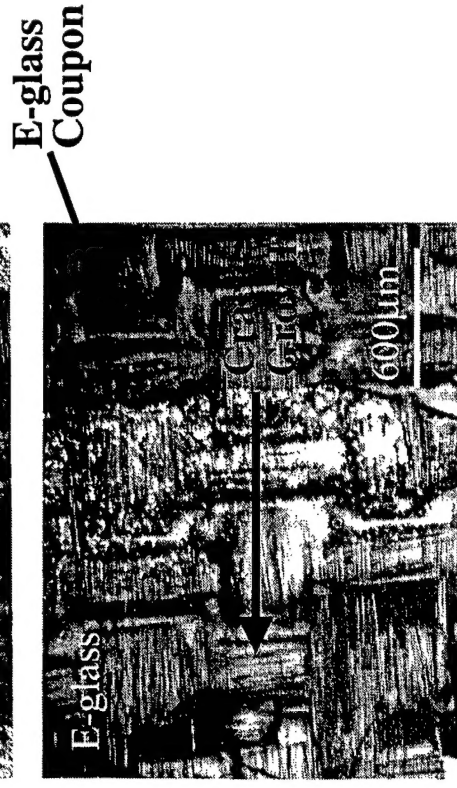
Fig. 33

Spallation of steel/E-glass sample under ambient conditions

Spallation of steel/E-glass sample after two-day-humidity-exposure
